Service Bulletin

BRS Harness and Pickup Collar Verification

SB-ASTM-CTSW-17
SB-ASTM-CTLS-20
SB-ELA-CTLS-004

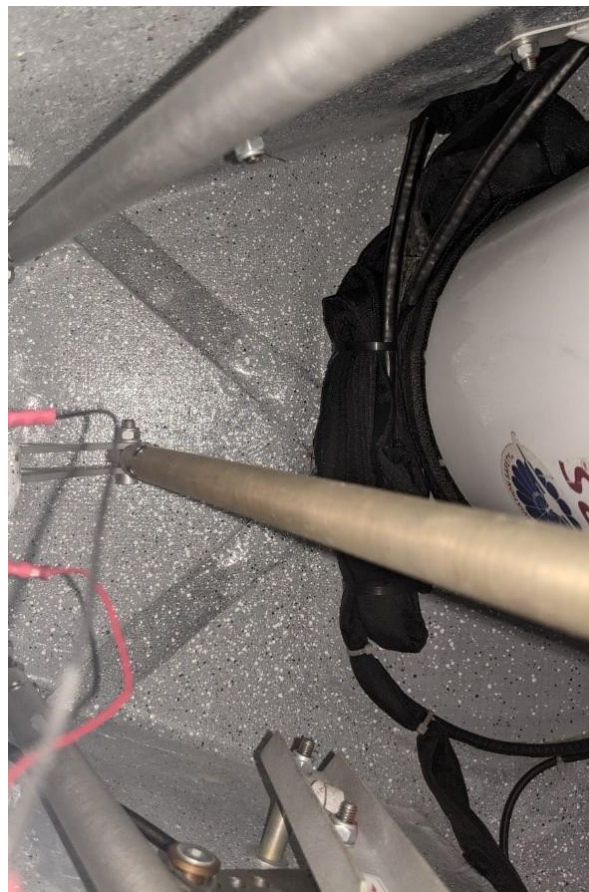
Fig 1

incorrectly installed harness
early model CTLS (2008 ... 2009)

Please notice the way that the harness bundle is on top of the canister on both of these pictures. The harness bundle must be in front of (to the left in these pictures-the direction of flight is to the left).

If the harness bundle is on top of the canister you must secure it further forward by moving the bundle behind the plastic edge protector of the hatch and securing it with ty-wraps using the small slots cut into the edge of the hatch hole in the fuselage. If you cannot move the bundle behind, you can also move it slightly more to the left-hand side towards the carabiner as shown in Fig 3.

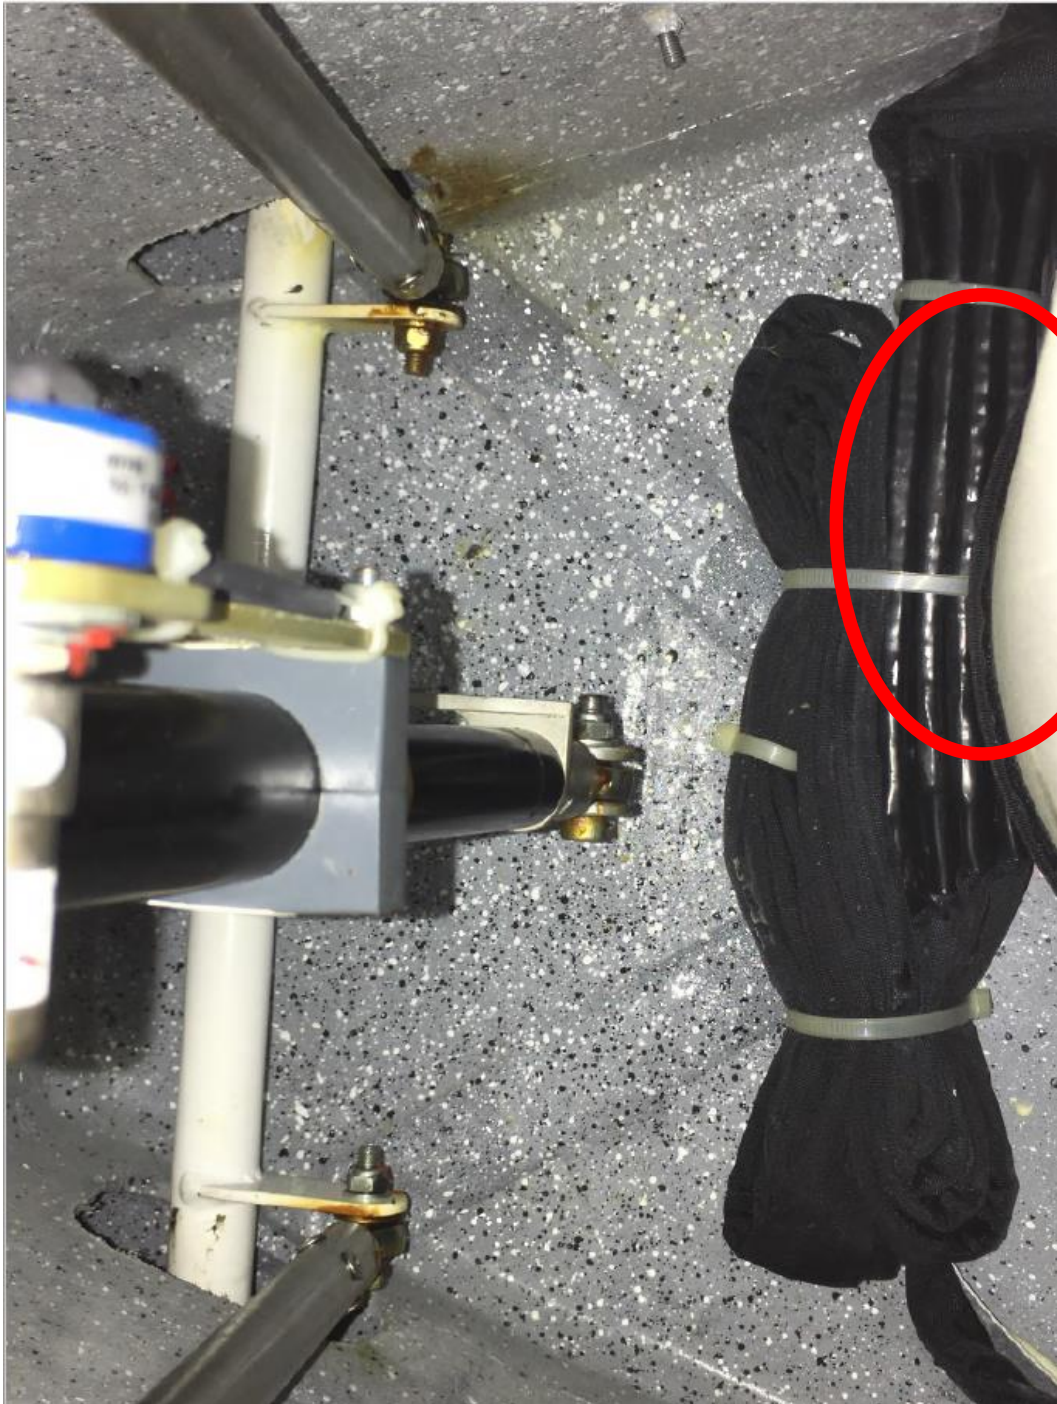
Fig 2

incorrectly installed harness
later model CTLS (2009 and on)

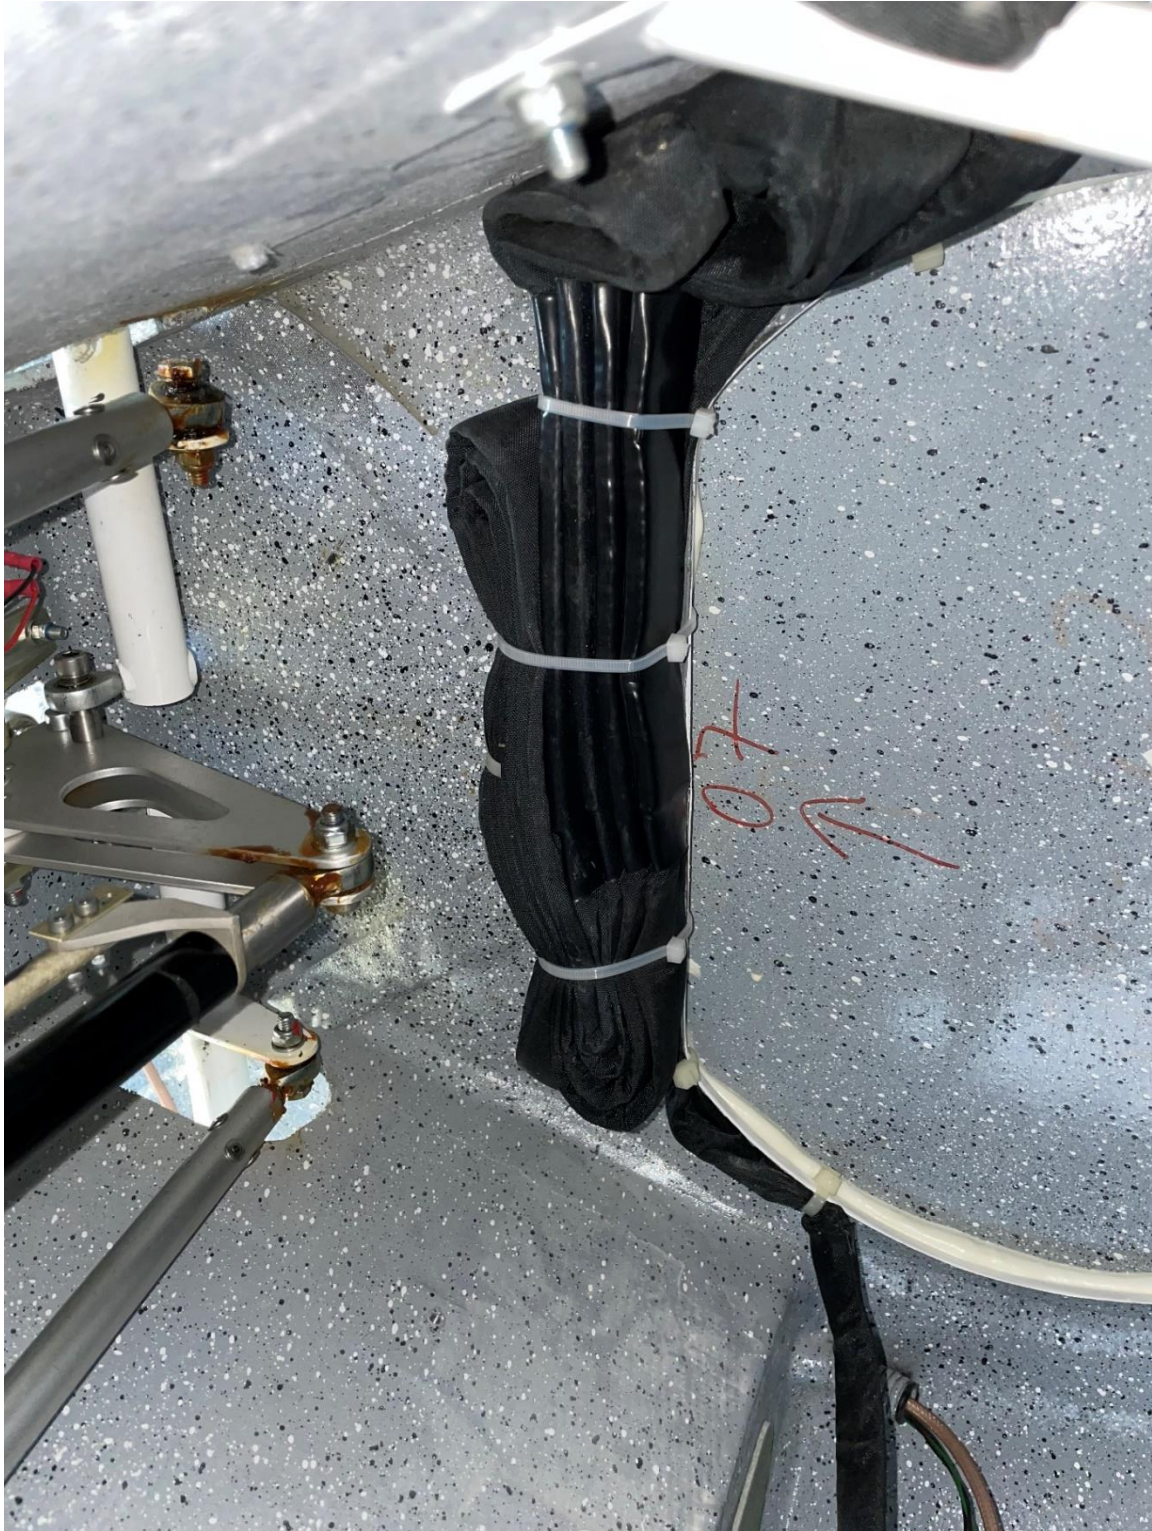
Fig 3 (Note: edge protection not installed in order to clearly show composite edge)
proper installation of harness bundle

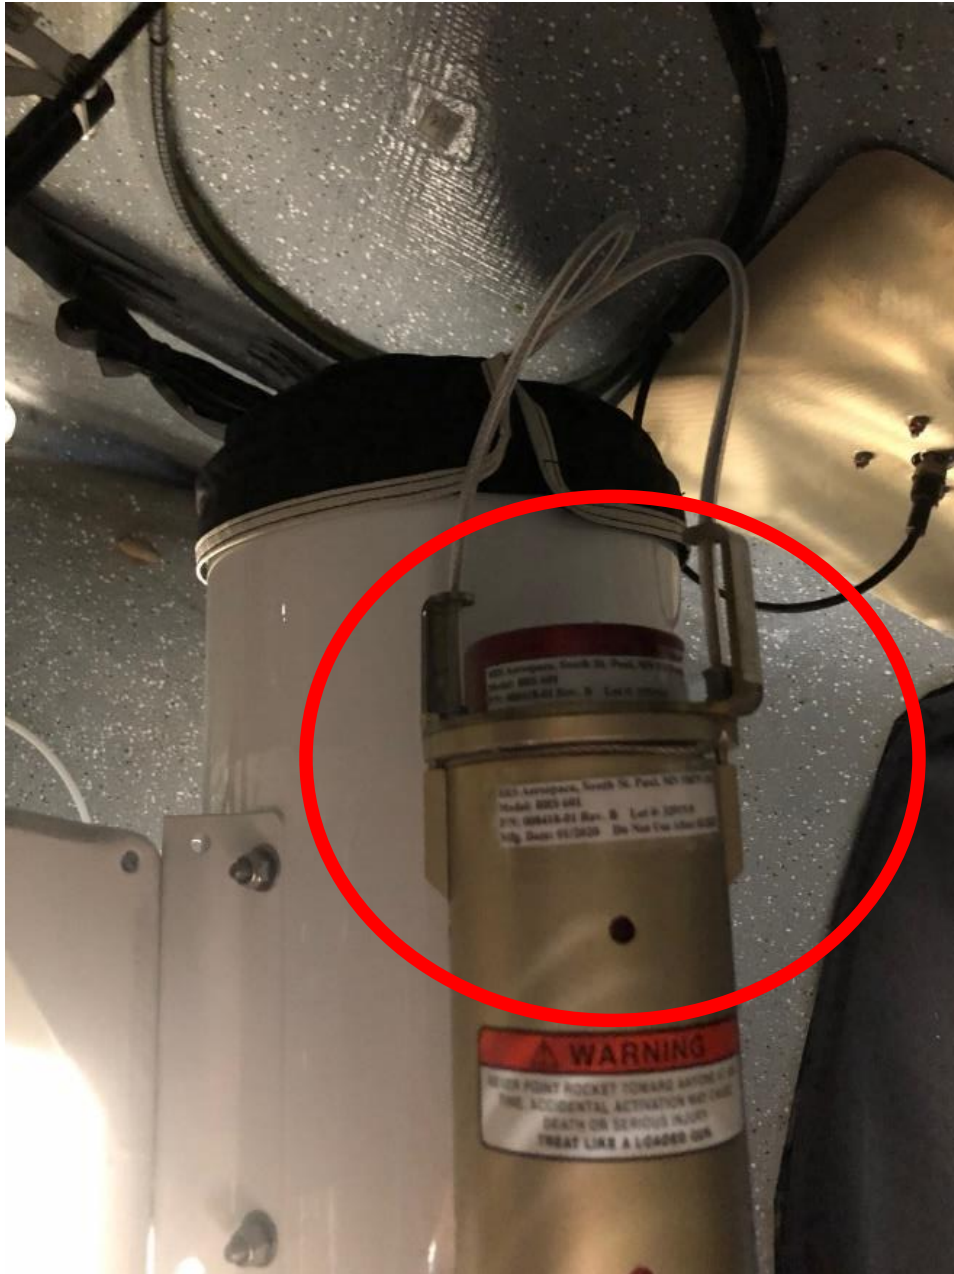
Fig 4

Mis-installed collar on CTSW.
 Collar mounted in reverse direction (upside down).

If the BRS rocket pickup collar is incorrectly mounted, you must contact BRS support to get replacement aluminum mounting screws for reinstalling the pickup collar correctly as shown in the Flight Design/BRS Service Alert SA-ASTM-CTLS-05 pickup collar HS 1350.

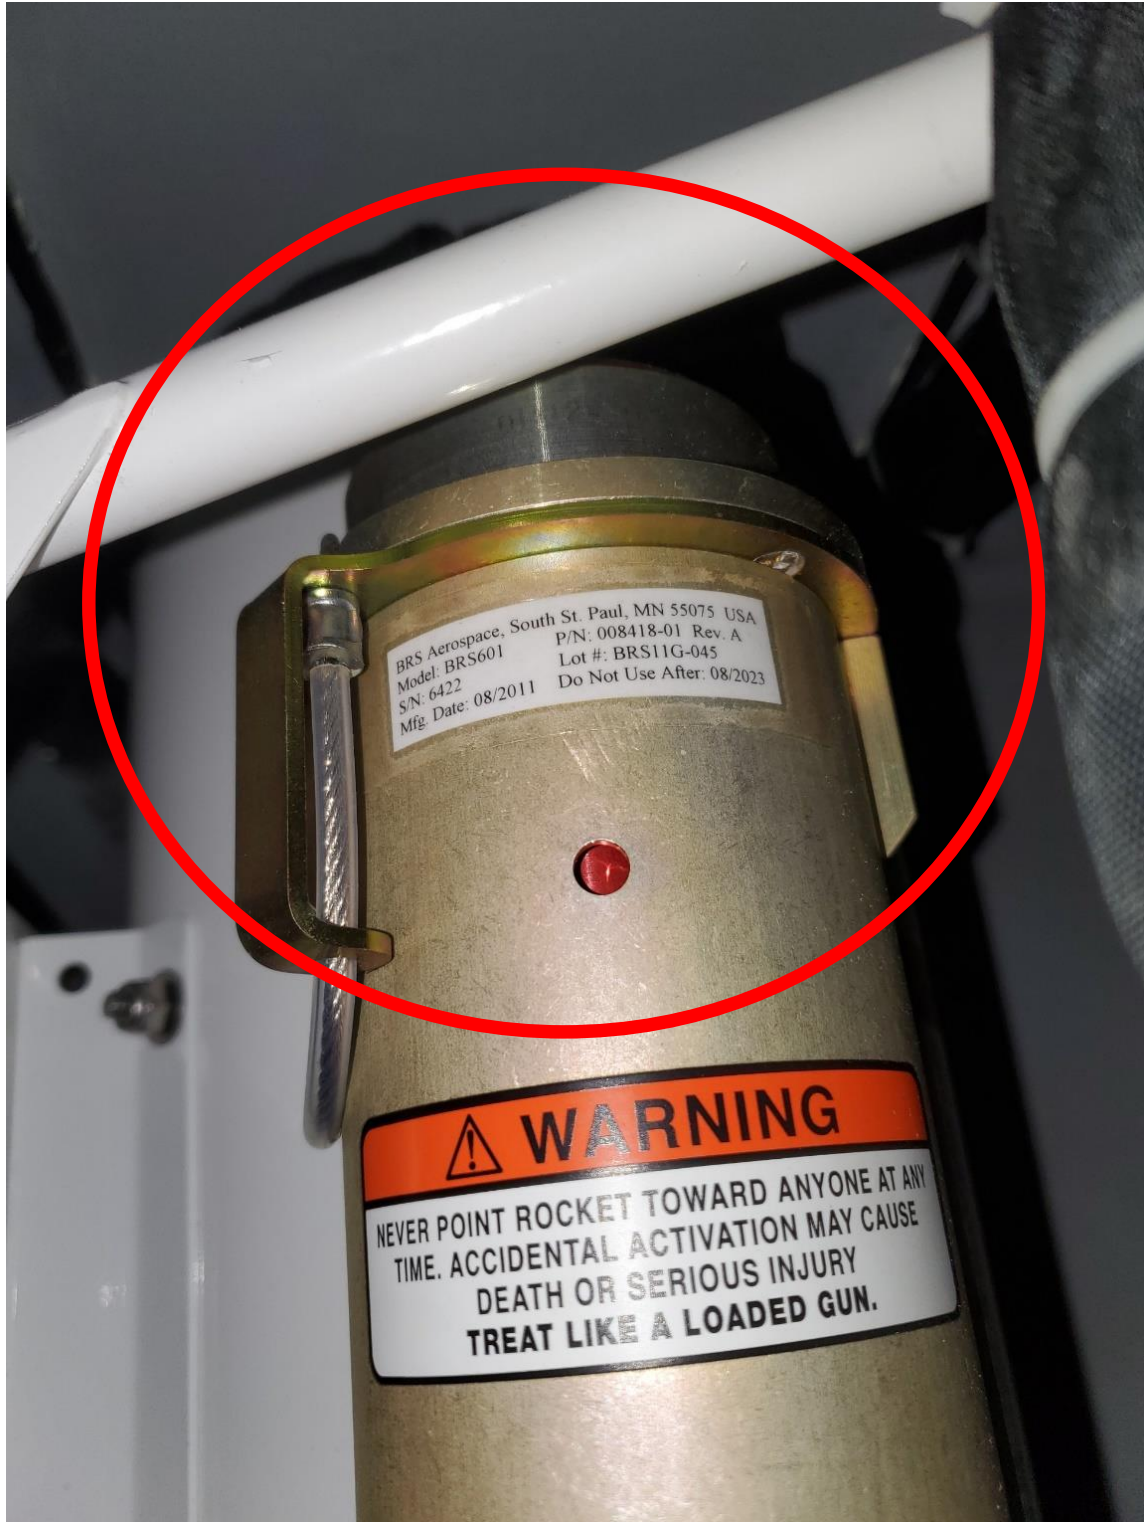
Fig 5

Properly installed collar on CTLS. Cables swing toward BRS canister and are not twisted.

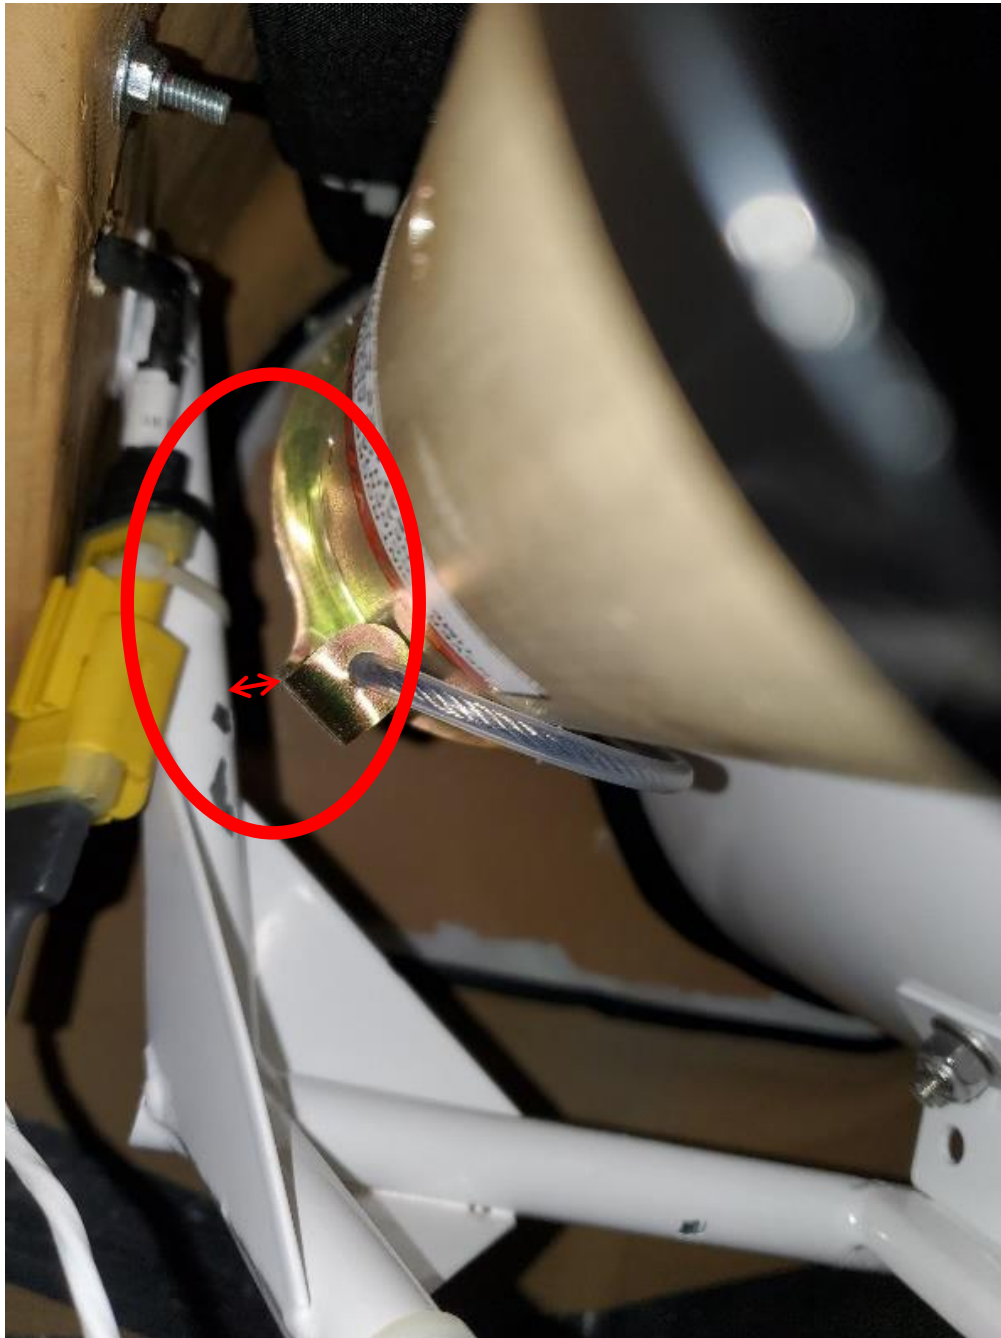
Fig 6

Make certain that there is clearance between the BRS rocket pickup collar and the white tubular structure mounting as shown in Fig 6.

Correctly installed collar on CTLS.
Proper clearance between collar and tubular structure mounting

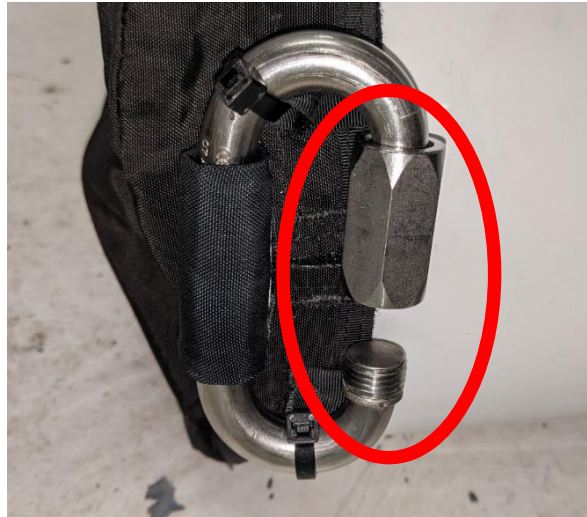
Fig 7

open carabiner (incorrect!!!)

Make certain that the carabiner is properly mounted and threaded tight. Make sure there no part of the harness bundle of straps caught in the threads.

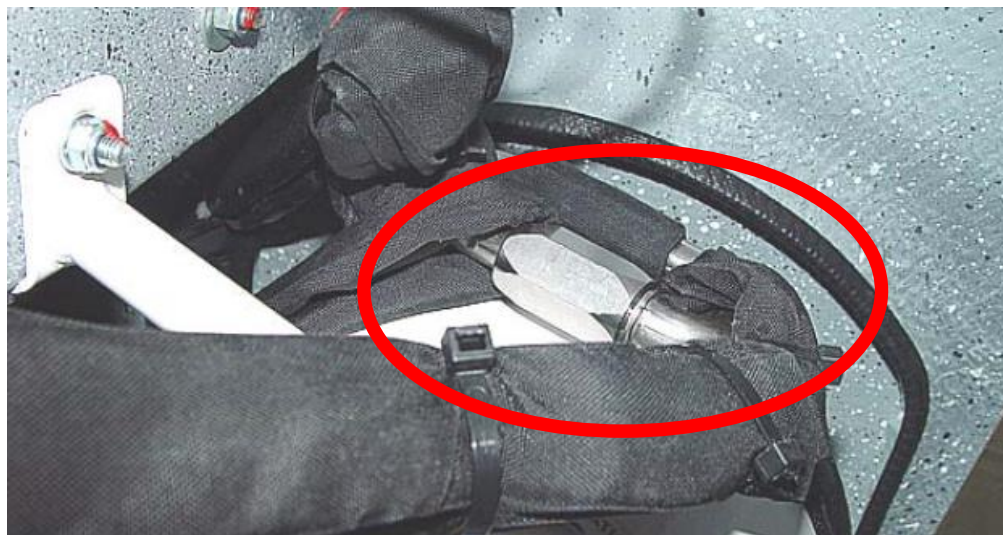
Fig 8

closed carabiner (properly installed)
